**WILLIAM HAYES LAKE DAM
BENTON COUNTY, MISSOURI
MO 31052**

**PHASE 1 INSPECTION REPORT
NATIONAL DAM SAFETY PROGRAM**

WILLIAM HAYES LAKE DAM
BENTON COUNTY, MISSOURI
MISSOURI INVENTORY NO. 31052

Name of Dam:	William Hayes Lake Dam
State Located:	Missouri
County Located:	Benton County
Stream:	Tributary to Lake of the Ozarks
Date of Inspection:	6 September 1979

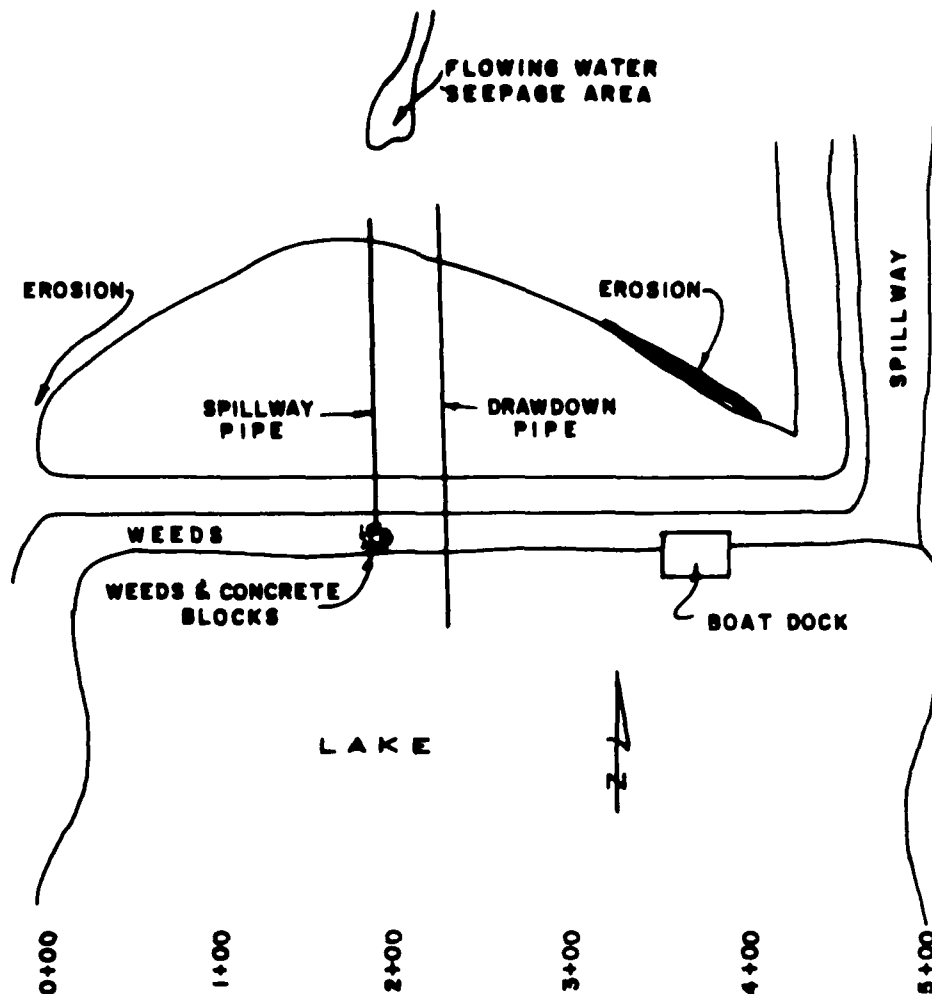
PLAN SKETCH
INSPECTION OBSERVATION
DAM No. MO. 31052

The embankment of the dam appears to be in good condition. No sloughing of the embankment was noted. The horizontal alignment of the dam is straight. The crest of the embankment is fairly level and no surface cracking or unusual movement was obvious. Shallow auger probes into the embankment indicated the top portion of the embankment to consist of red-brown silty clay with chert fragments. Slight erosion at the west abutment and downstream embankment was noted. An erosion channel approximately two ft. wide and one foot deep was observed at the east downstream contact. No additional erosional areas were observed.
